**Flood Control Project Maintenance
Levee Inspections**

Fall 2015 Levee Maintenance Deficiency Summary Report

Sacramento River Basin

Lake County Watershed Protection District

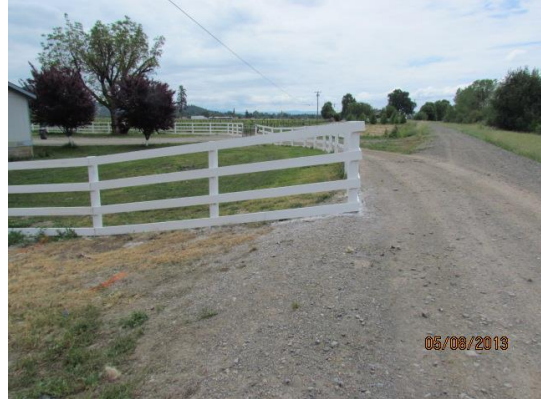
Photo 1 of 1 : FA_2015_NA0009_3_12_20150910_00006.jpg

LM Start	0.12	Rating **	M	Issue No.	12
LM End	0.12	Issue Type +	En	Location *	LS
Category	Earthen Levee			GPS Latitude/Longitude	
				Start	End
Item	Encroachments			39.188877 °	39.188877 °
				-122.907581 °	-122.907581 °
DWR ID	DWR_NA0009_01_s _ 2013_12				
Action/Comments					
Fence

View of the unauthorized encroachment fence along landside slope.

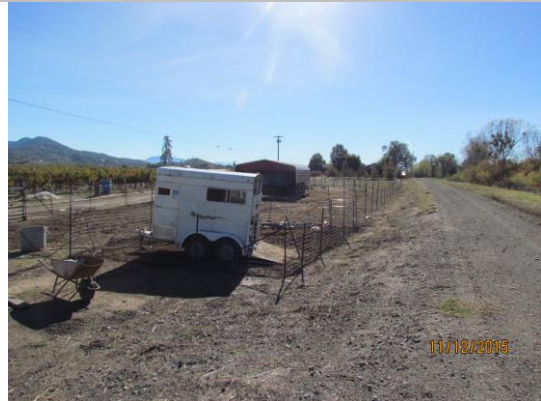
Photo 1 of 1 : FA_2015_NA0009_3_24_20151112_00022.jpg

LM Start	0.14	Rating **	M	Issue No.	24
LM End	0.22	Issue Type +	En	Location *	LS
Category	Earthen Levee			GPS Latitude/Longitude	
				Start	End
Item	Encroachments			39.188465 °	39.187392 °
				-122.907687 °	-122.907885 °
DWR ID	DWR_NA0009_01_f _ 2015_24				
Action/Comments					
Fence					
Inspector Comments: Remove the fence from the landside toe.

View of the fence along the landside toe.

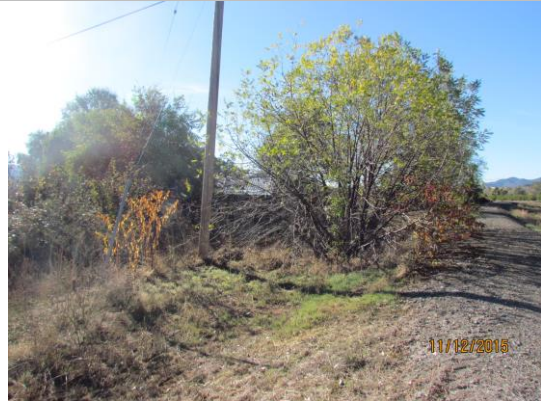
Photo 2 of 2 : FA_2015_NA0009_3_11_20151112_00017.jpg

LM Start	0.26	Rating **	M	Issue No.	11 (cont)
LM End	0.26	Issue Type +	Ma	Location *	LS
Category	Earthen Levee			GPS Latitude/Longitude	
				Start	End
Item	Trim / Thin Trees			39.186777 °	39.186777 °
				-122.908102 °	-122.908102 °
DWR ID	DWR_NA0009_01_s _ 2013_11				
Action/Comments					
Trim and thin trees to allow visibility of the ground and room to flood fight.					
Inspector Comments: Remove the trees from the landside slope.

Remove the trees from the landside slope.

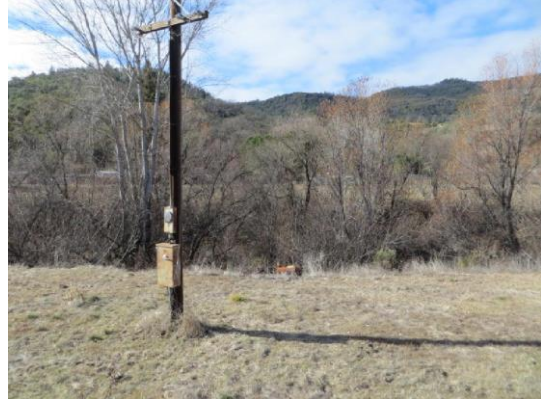
Photo 1 of 3 : UCIP_FA_2015_3427.jpg

LM Start	0.56	Rating **	M	Issue No.	535
LM End	0.56	Issue Type +	En	Location *	LS
Category	Supplemental			GPS Latitude/Longitude	
				Start	End
Item	DWR UCIP Field Study			39.183519 °	39.183519 °
				-122.911379 °	-122.911379 °
DWR ID					
Action/Comments					
Inspector Comments: FS_ID:26943 DS_ID:21193 EP_NO: 5237 FS_HLM: 0.558 Repair Type: Non-Urgent Crossing Status: Found UCIP Comments: Pipe appears abandoned and should be done so properly. FIELD_STRUCT_DESC: 6-inch steel pipe possibly sleeved through an 8-inch steel pipe, 3.0-feet below the crown. Siphon breaker in 24-inch CMP riser on the landward slope. Reinforced concrete cutoff wall at center of levee. Butterfly valve on the waterward side at pump on concrete base on the waterward bank, installed under Permit No. 5237 (1971). Pole on the waterward berm, with overhead power line supplying electricity to pump. Originally included in the 1961 O+M manual. FS Date: 01/09/2014

Power pole, meter, and pump visible on WS berm.

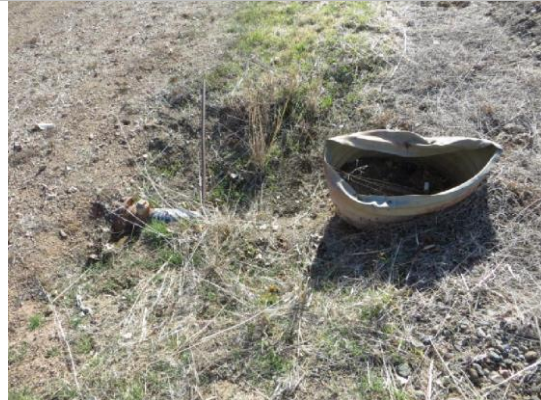
Photo 2 of 3 : UCIP_FA_2015_3428.jpg

Pipe and siphon breaker visible on LS slope.

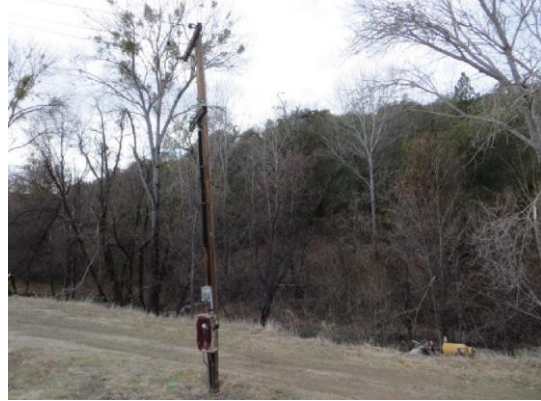
Photo 2 of 3 : UCIP_FA_2015_3440.jpg

Inspector Comments: FS_ID:26946
 DS_ID:21196
 EP_NO: N/A
 FS_HLM: 0.845
 Repair Type: Non-Urgent
 Crossing Status: Found
 UCIP Comments: Pump and pipe appear abandoned and should be done so properly.
 FIELD_STRUCT_DESC: 8-inch steel irrigation pipe through the levee, 3.0 feet below the crown. Siphon breaker in 24-inch CMP riser on landward slope. Pump on the waterward bank with a butterfly valve. Service pole on the waterward berm. (USACE-1961). This entry matches the Drainage or Irrigation Structure referenced in O&M manual (HLM 0.83).
 FS Date: 01/09/2014

Pump, pole, and meter on WS berm.

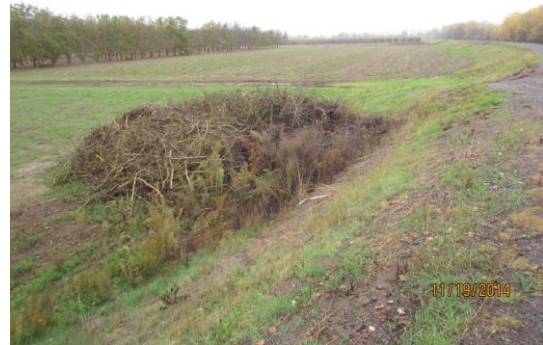
Photo 1 of 1 : FA_2015_NA0009_3_290_20150910_00012.jpg

LM Start	1.57	Rating **	M	Issue No.	290
LM End	1.57	Issue Type +	En	Location *	LS
Category	Earthen Levee			GPS Latitude/Longitude	
				Start	End
Item	Encroachments			39.169918 °	39.169918 °
				-122.915197 °	-122.915197 °
DWR ID	DWR_NA0009_01_f_2014_290				
Action/Comments					
Prunings

View of the prunings along the landside toe.

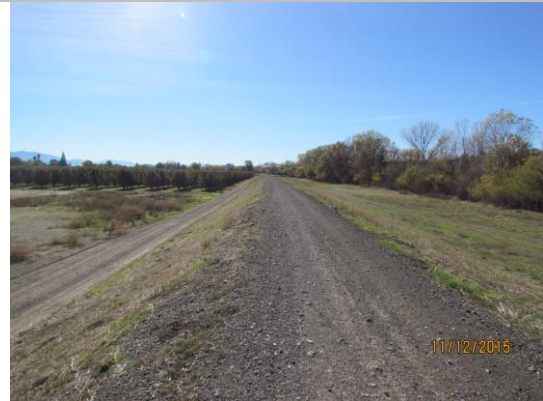
Photo 1 of 1 : FA_2015_NA0009_3_22_20151112_00020.jpg

LM Start	1.75	Rating **	A	Issue No.	22
LM End	1.75	Issue Type +	Ma	Location *	LS
Category	Earthen Levee			GPS Latitude/Longitude	
				Start	End
Item	Vegetation			39.167267 °	39.167267 °
				-122.915587 °	-122.915587 °
DWR ID	DWR_NA0009_01_f_2015_22				
Action/Comments					
Control annual grass and weeds on the levee slopes and easements. Inspector Comments: Lake Co. mowed both slopes.

View of no vegetation on both slopes.

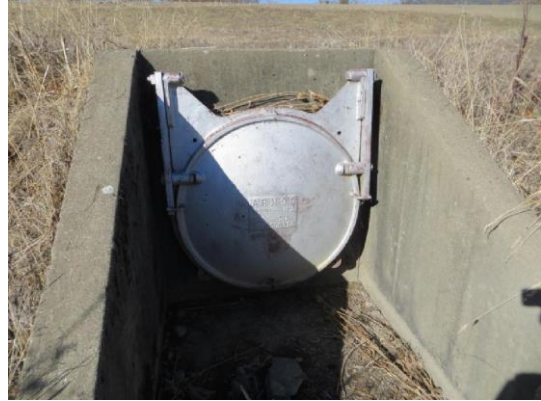
Photo 1 of 3 : UCIP_FA_2015_3469.jpg

Action/Comments					
Inspector Comments: FS_ID:27004 DS_ID:21199 EP_NO: 11460 FS_HLM: 2.353 Repair Type: Non-Urgent Crossing Status: Found UCIP Comments: Heavy vegetation on LS at inlet should be removed. FIELD_STRUCT_DESC: 42-inch CM drainpipe through the levee, 10.0 feet below the crown. Flap gate on waterward end. Concrete headwall on both ends. Originally included in 1961 O+M manual. Pipe retained under ABO No. 11460 (1975). FS Date: 01/14/2014

Concrete U-shaped headwall and flap gate on WS berm.

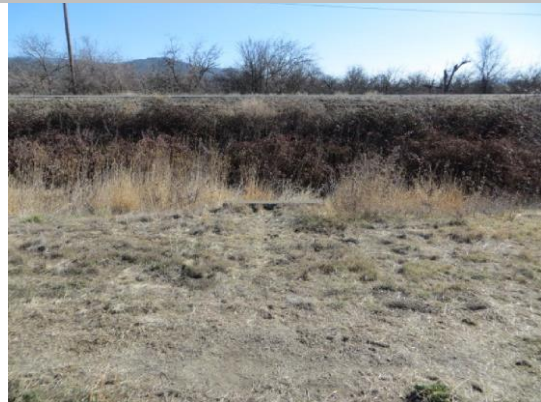
Photo 2 of 3 : UCIP_FA_2015_3470.jpg

Concrete U-shaped headwall on WS berm.

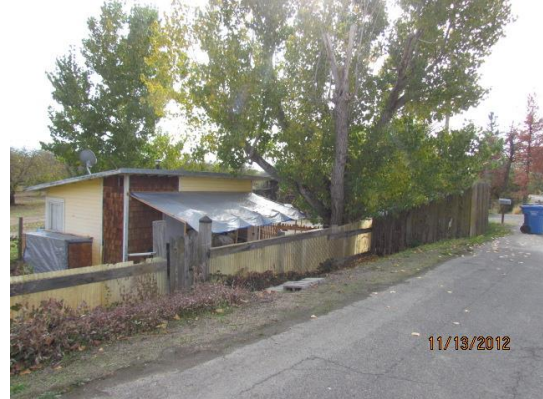
Photo 1 of 1 : FA_2015_NA0009_3_7_20150910_00004.jpg

LM Start	2.47	Rating **	M	Issue No.	7
LM End	2.59	Issue Type +	En	Location *	LS
Category	Earthen Levee			GPS Latitude/Longitude	
				Start	End
Item	Encroachments			39.161692 °	39.160217 °
				-122.911748 °	-122.912957 °
DWR ID	DWR_NA0009_01_s _ 2012_7				
Action/Comments					
Building

View of a building & fence along the toe of the levee.

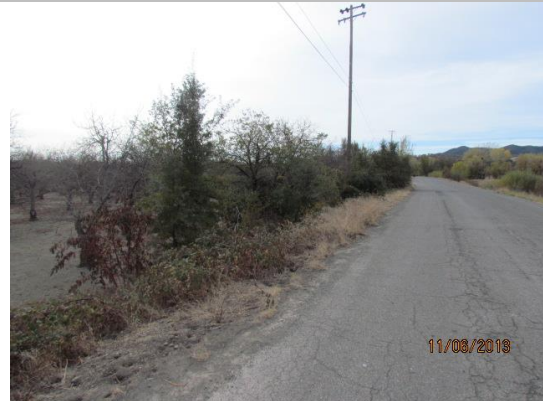
Photo 1 of 1 : FA_2015_NA0009_3_3_20150910_00001.jpg

LM Start	2.48	Rating **	M	Issue No.	3
LM End	2.54	Issue Type +	Ma	Location *	LS
Category	Earthen Levee			GPS Latitude/Longitude	
				Start	End
Item	Vegetation			39.161615 °	39.160795 °
				-122.911733 °	-122.912442 °
DWR ID	DWR_NA0009_01_s _ 2012_3				
Action/Comments					
Remove the wild growth other than native grasses from the levee slopes.

View of the vegetation along the landside slope.

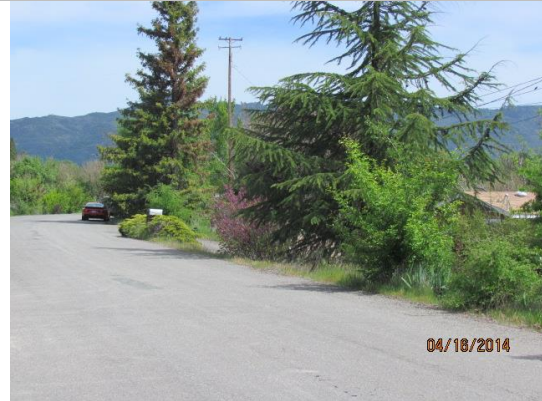
Photo 1 of 1 : FA_2015_NA0009_3_5_20150910_00003.jpg

LM Start	2.64	Rating **	M	Issue No.	5
LM End	2.64	Issue Type +	En	Location *	LS
Category	Earthen Levee			GPS Latitude/Longitude	
				Start	End
Item	Vegetation			39.159657 °	39.159657
				-122.913345 °	-122.913345
DWR ID	DWR_NA0009_01_s _ 2012_5				
Action/Comments					
Landscaping

View of the landscape along the landside slope.

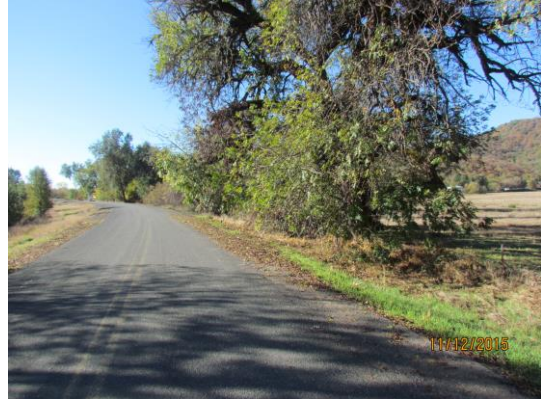
Photo 1 of 1 : FA_2015_NA0009_4_4_20151112_00018.jpg

LM Start	0.02	Rating **	M	Issue No.	4
LM End	0.14	Issue Type +	Ma	Location *	LS
Category	Earthen Levee			GPS Latitude/Longitude	
				Start	End
Item	Trim / Thin Trees			39.189540 °	39.187900 °
				-122.908065 °	-122.908655 °
DWR ID	DWR_NA0009_02_s _ 2013_4				
Action/Comments					
Trim trees to at least five feet above ground level.					
Inspector Comments: Trim the trees up 5 feet to allow visibility.

Trim the trees up 5 feet to allow visibility.

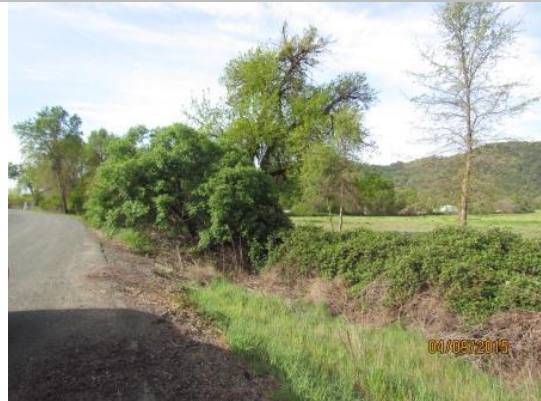
Photo 1 of 1 : FA_2015_NA0009_4_19_20150910_00009.jpg

LM Start	0.08	Rating **	M	Issue No.	19
LM End	0.08	Issue Type +	Ma	Location *	LS
Category	Earthen Levee			GPS Latitude/Longitude	
				Start	End
Item	Vegetation			39.188772 °	39.188772 °
				-122.908465 °	-122.908465 °
DWR ID	DWR_NA0009_02_s _ 2014_19				
Action/Comments					
Elderberries are blocking visibility and flood fight capability.

View of the elderberries along the landside toe.

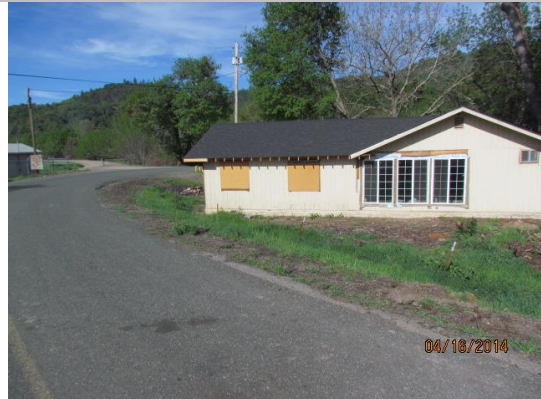
Photo 1 of 1 : FA_2015_NA0009_4_1_20150910_00001.jpg

LM Start	0.20	Rating **	U	Issue No.	1
LM End	0.20	Issue Type +	En	Location *	LS
Category	Earthen Levee			GPS Latitude/Longitude	
				Start	End
Item	Encroachments			39.187039 °	39.187039 °
				-122.908880 °	-122.908880 °
DWR ID	DWR_NA0009_02_s _ 2012_1				
Action/Comments					
Building

View of the building on the landside toe.

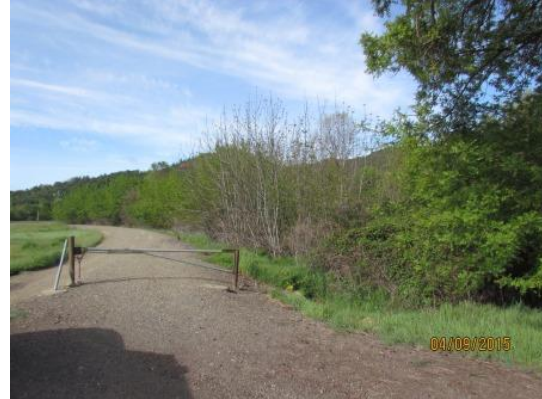
Photo 1 of 1 : FA_2015_NA0009_4_9_20150910_00007.jpg

LM Start	0.24	Rating **	M	Issue No.	9
LM End	0.29	Issue Type +	Ma	Location *	LS
Category	Earthen Levee			GPS Latitude/Longitude	
				Start	End
Item	Trim / Thin Trees			39.186739 °	39.186038
				-122.909436 °	-122.909948
DWR ID	DWR_NA0009_02_s_2013_9				
Action/Comments					
Trim trees to at least five feet above ground level.					
Inspector Comments: Trim the trees up 5 feet to allow visibility.

Trim the trees up 5 feet to allow visibility.

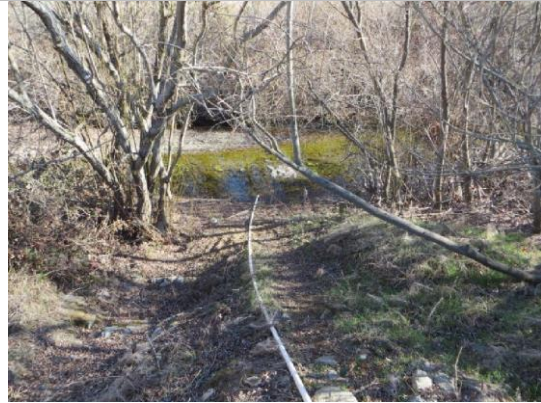
Photo 2 of 3 : UCIP_FA_2015_3122.jpg

LM Start	0.48	Rating **	M	Issue No.	20 (cont)	
LM End	0.48	Issue Type +	En	Location *	LS	
Category	Supplemental			GPS Latitude/Longitude		
				Start	End	
Item	DWR UCIP Field Study			39.184080 °	39.184080 °	
				-122.912130 °	-122.912130 °	
DWR ID						
Action/Comments						
Inspector Comments: FS_ID:27563 DS_ID:24761 EP_NO: N/A FS_HLM: 0.48 Repair Type: Non-Urgent Crossing Status: Found UCIP Comments: No Permit identified for crossing. FIELD_STRUCT_DESC: 1.5-inch HDPE irrigation pipe through the levee at unknown depth below the crown. Pipe visible on WS berm slope. Pumphouse on LS toe. FS Date: 01/14/2014

Pipe visible just downstream from stormdrain.

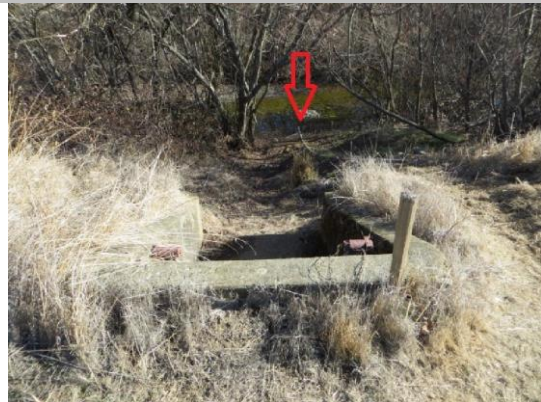
Photo 3 of 3 : UCIP_FA_2015_3123.jpg

Pipe visible just downstream from stormdrain.

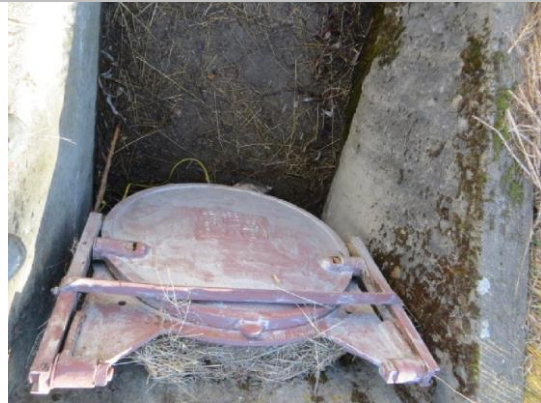
Photo 1 of 3 : UCIP_FA_2015_3472.jpg

LM Start	0.55	Rating **	M	Issue No.	22
LM End	0.55	Issue Type +	En	Location *	LS
Category	Supplemental			GPS Latitude/Longitude	
				Start	End
Item	DWR UCIP Field Study			39.183130 °	39.183130 °
				-122.912198 °	-122.912198 °
DWR ID					
Action/Comments					
Inspector Comments: FS_ID:27208					
DS_ID:21210					
EP_NO: 11482					
FS_HLM: 0.545					
Repair Type: Non-Urgent					
Crossing Status: Found					
UCIP Comments: Fence on LS slope creates access issue.					
FIELD_STRUCT_DESC: 36-inch CM drainpipe through the levee, 9.0 feet below the crown. Flap gate on the waterward end. Concrete headwalls on both ends. (USACE-1961). This entry matches the Drainage or Irrigation Structure referenced in O&M manual (HLM 0.54). This pipe was retained under ABO No. 11482 (1975).					
FS Date: 01/14/2014

Flapgate and concrete headwall on WS berm.

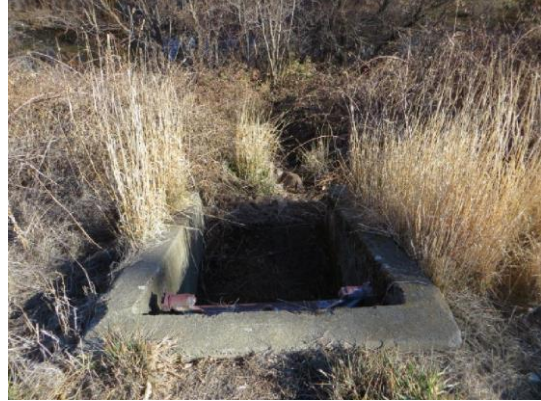
Photo 2 of 3 : UCIP_FA_2015_3473.jpg

Inspector Comments: FS_ID:27208
 DS_ID:21210
 EP_NO: 11482
 FS_HLM: 0.545
 Repair Type: Non-Urgent
 Crossing Status: Found
 UCIP Comments: Fence on LS slope creates access issue.
 FIELD_STRUCT_DESC: 36-inch CM drainpipe through the levee, 9.0 feet below the crown. Flap gate on the waterward end. Concrete headwalls on both ends. (USACE-1961). This entry matches the Drainage or Irrigation Structure referenced in O&M manual (HLM 0.54). This pipe was retained under ABO No. 11482 (1975).
 FS Date: 01/14/2014

Flapgate and concrete headwall on WS berm.

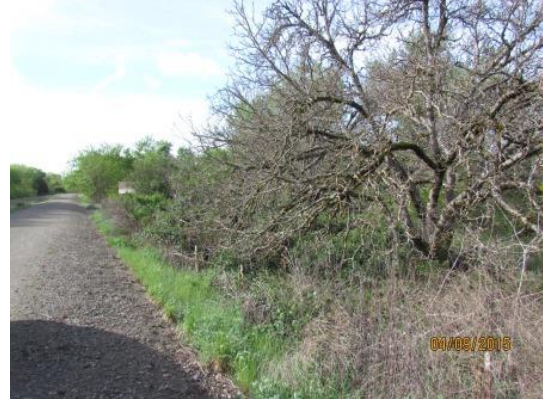
Photo 1 of 2 : FA_2015_NA0009_4_7_20150910_00006.jpg

LM Start	0.97	Rating **	M	Issue No.	7
LM End	0.98	Issue Type +	Ma	Location *	LS
Category	Earthen Levee			GPS Latitude/Longitude	
				Start	End
Item	Vegetation			39.177218 °	39.176992 °
				-122.913673 °	-122.913642 °
DWR ID	DWR_NA0009_02_s _ 2012_7				
Action/Comments					
Remove the wild growth other than native grasses from the levee slopes.					
Inspector Comments: Remove the vegetation from the landside toe.

Remove the vegetation from the landside toe.

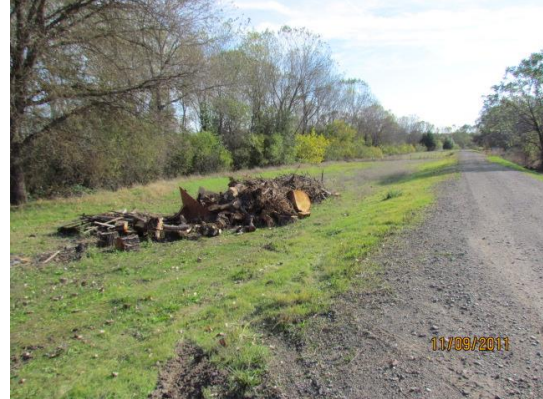
Photo 1 of 1 : FA_2015_NA0009_4_3_20150910_00003.jpg

LM Start	0.99	Rating **	M	Issue No.	3
LM End	0.99	Issue Type +	Ma	Location *	WS
Category	Earthen Levee			GPS Latitude/Longitude	
				Start	End
Item	Encroachments			39.176835 °	39.176835
				-122.913558 °	-122.913558
DWR ID	DWR_NA0009_02_s_2012_3				
Action/Comments					
Tree or limb

View of the tree prunings on the W/S toe.

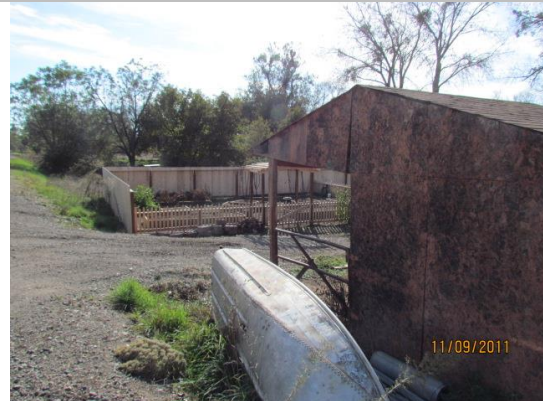
Photo 1 of 1 : FA_2015_NA0009_4_2_20150910_00002.jpg

LM Start	0.99	Rating **	U	Issue No.	2
LM End	0.99	Issue Type +	En	Location *	LS
Category	Earthen Levee			GPS Latitude/Longitude	
				Start	End
Item	Encroachments			39.176815 °	39.176815 °
				-122.913540 °	-122.913540 °
DWR ID	DWR_NA0009_02_s_2012_2				
Action/Comments					
Fence					
Inspector Comments: Unpermitted fence and building.

View of the building & fence along the Landside toe.

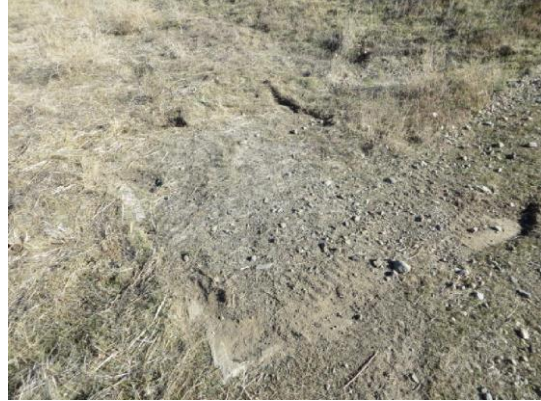
Photo 1 of 2 : UCIP_FA_2015_3060.jpg

6'X8' concrete sump filled in with soil, visible at LS toe.

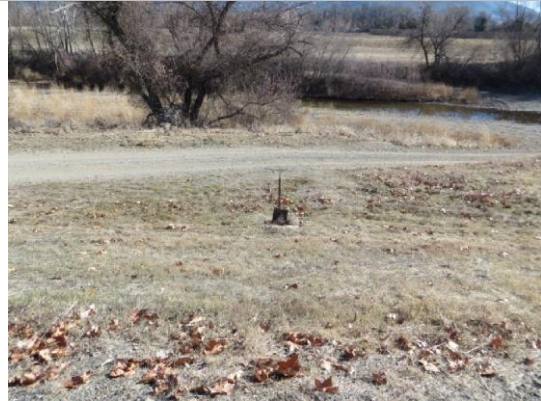
Photo 1 of 2 : UCIP_FA_2015_3062.jpg

T-post at WS toe may indicate location of pipe end. Covered with soil.

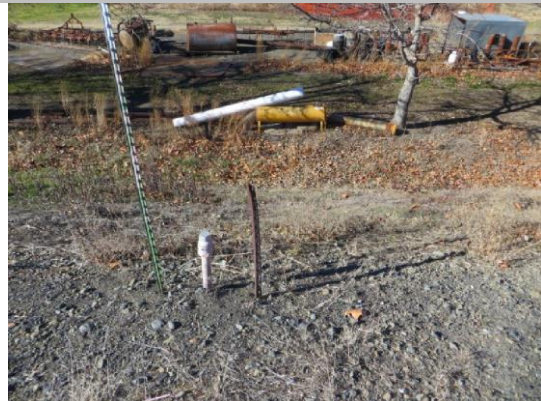
Photo 2 of 2 : UCIP_FA_2015_3063.jpg

Vent on LS shoulder with filter visible on LS toe.

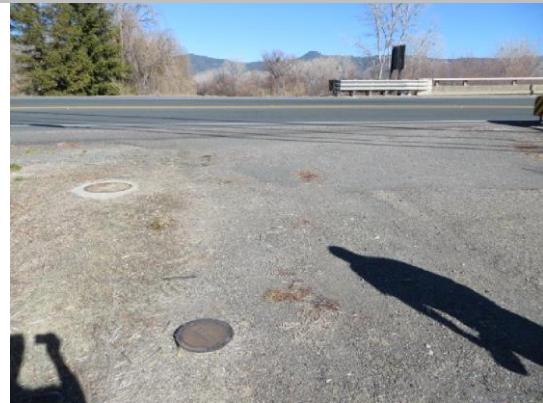
Photo 1 of 2 : UCIP_FA_2015_3064.jpg

LM Start	1.96	Rating **	M	Issue No.	26
LM End	1.96	Issue Type +	En	Location *	LS
Category	Supplemental			GPS Latitude/Longitude	
				Start	End
Item	DWR UCIP Field Study			39.163414 °	39.163414 °
				-122.916741 °	-122.916741 °
DWR ID					
Action/Comments					
Inspector Comments: FS_ID:27624					
DS_ID:21243					
EP_NO: 15865					
FS_HLM: 2.027					
Repair Type: Non-Urgent					
Crossing Status: Found					
UCIP Comments: Permit number likely revised from 15865. Verify with inspector and modify entry as required.					
FIELD_STRUCT_DESC: 8-inch steel sewer line (pressurized) through the levee, 3.0 feet below the crown. Cutoff wall around pipe at center of levee. Siphon breaker on waterward levee shoulder. Pipe visible under bridge (Permit No. 15865-1991).					
FS Date: 01/22/2014

Manhole and vent lids visible on LS shoulder.

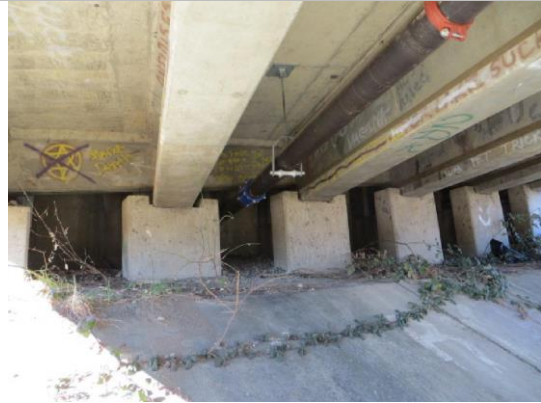
Photo 2 of 2 : UCIP_FA_2015_3065.jpg

Pipe visible under bridge.

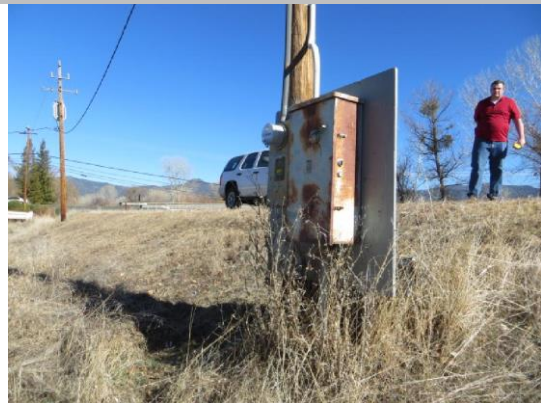
Photo 1 of 2 : UCIP_FA_2015_3066.jpg

LM Start	2.00	Rating **	M	Issue No.	27
LM End	2.00	Issue Type +	En	Location *	LS
Category	Supplemental			GPS Latitude/Longitude	
				Start	End
Item	DWR UCIP Field Study			39.162753 °	39.162753 °
				-122.916811 °	-122.916811 °
DWR ID					
Action/Comments					
Inspector Comments: FS_ID:27629 DS_ID:21250 EP_NO: 17191 FS_HLM: 2.073 Repair Type: Non-Urgent Crossing Status: Found UCIP Comments: Appears abandoned, if so it should be done so properly. FIELD_STRUCT_DESC: 2 of 2: 2-inch PVC pipe through the levee, 2.0 feet below the crown. Well and electric pump at waterward toe. Pole and meter(Permit No. 17191-2000) FS Date: 01/22/2014

Meter and control on LS slope next to pole.

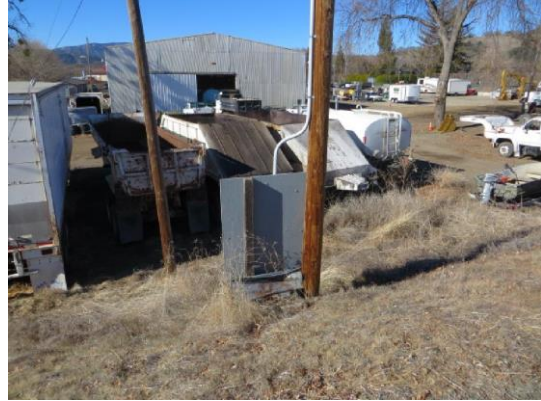
Photo 2 of 2 : UCIP_FA_2015_3067.jpg

Meter and control on LS slope next to pole.

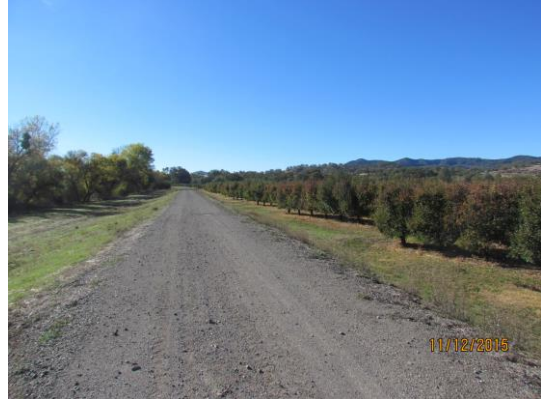
Photo 1 of 1 : FA_2015_NA0009_4_18_20151112_00021.jpg

LM Start	2.35	Rating **	A	Issue No.	18
LM End	2.35	Issue Type +	Ma	Location *	LS
Category	Earthen Levee			GPS Latitude/Longitude	
				Start	End
Item	Vegetation			39.158193 °	39.158193 °
				-122.914763 °	-122.914763 °
DWR ID	DWR_NA0009_02_f_2015_18				
Action/Comments					
Control annual grass and weeds on the levee slopes and easements. Inspector Comments: Lake Co. mowed both slopes.

View of acceptable vegetation on both slopes.

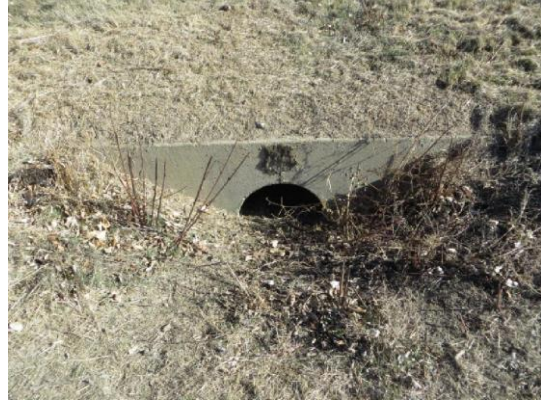
Photo 1 of 3 : UCIP_FA_2015_3221.jpg

Action/Comments					
Inspector Comments: FS_ID:27630 DS_ID:21215 EP_NO: 11481 FS_HLM: 2.916 Repair Type: Non-Urgent Crossing Status: Found UCIP Comments: Soil partially blocking inlet and outlet. FIELD_STRUCT_DESC: 24-inch CM drainpipe through the levee, 12.0 feet below the crown. Flap gate on the waterward end. Concrete headwalls on both ends. (USACE-1961). This entry matches the Drainage or Irrigation Structure referenced in O&M manual (HLM 2.93). This pipe was retained under ABO No. 11481 (1975). FS Date: 01/22/2014

Concrete headwall and pipe visible at LS toe.

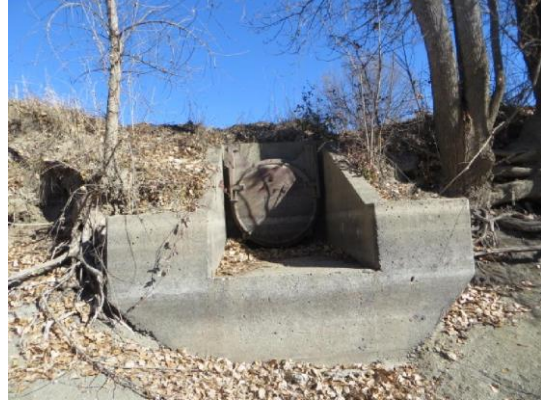
Photo 1 of 3 : UCIP_FA_2015_3363.jpg

Inspector Comments: FS_ID:27863
 DS_ID:21217
 EP_NO: 11492
 FS_HLM: 0.53
 Repair Type: Non-Urgent
 Crossing Status: Found
 UCIP Comments: Vegetation at inlet and wooden box failing at LS toe.
 FIELD_STRUCT_DESC: 42-inch CM drainpipe through the levee, 12.0 feet below the crown. Flap gate on the waterward end. Concrete headwalls on both ends with a wooden retaining wall drop inlet at LS toe (USACE-1961). Originally included in O&M manual (HLM 0.55). This pipe was retained under ABO No. 11492 (1975). USACE O&M DWG No. CC-4-4-29.
 FS Date: 01/22/2014

Concrete headwall and flapgate visible at WS berm.

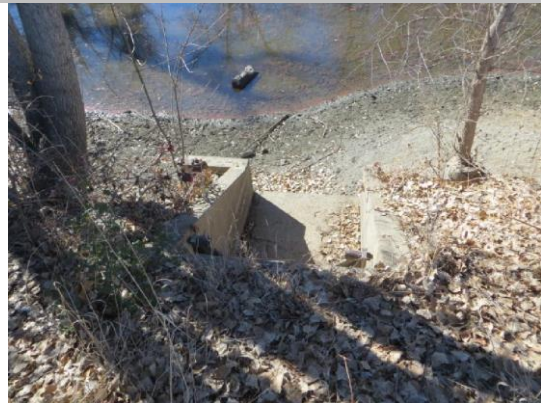
Photo 2 of 3 : UCIP_FA_2015_3364.jpg

Concrete headwall and flapgate visible at WS berm.

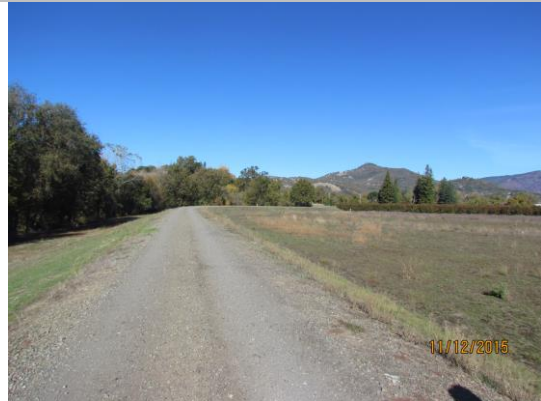
Photo 1 of 1 : FA_2015_NA0009_5_9_20151112_00009.jpg

LM Start	0.55	Rating **	A	Issue No.	9
LM End	0.55	Issue Type +	Ma	Location *	LS
Category	Earthen Levee			GPS Latitude/Longitude	
				Start	End
Item	Vegetation			39.154887 °	39.154887 °
				-122.918783 °	-122.918783 °
DWR ID	DWR_NA0009_03_f_2015_9				
Action/Comments					
Control annual grass and weeds on the levee slopes and easements. Inspector Comments: Lake Co. mowed both slopes.

View of acceptable vegetation on both slopes.

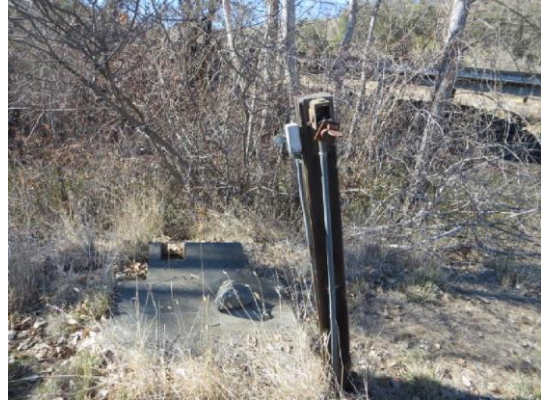
Photo 1 of 3 : UCIP_FA_2015_3385.jpg

Inspector Comments: FS_ID:27891
 DS_ID:21219
 EP_NO: 11492
 FS_HLM: 0.738
 Repair Type: Non-Urgent
 Crossing Status: Indicator Found
 UCIP Comments: Appears abandoned and if so should be done so properly.
 FIELD_STRUCT_DESC: 4-inch steel pipe through the levee, 2.5 feet below the crown. Siphon breaker in 24-inch CMP riser on LS shoulder. Pump on concrete platform on waterward side. Hose chute and concrete stairway on waterward slope. This pipe was retained under ABO No. 11492 (1975).
 FS Date: 01/22/2014

Concrete pump pad and electrical works visible on WS berm.

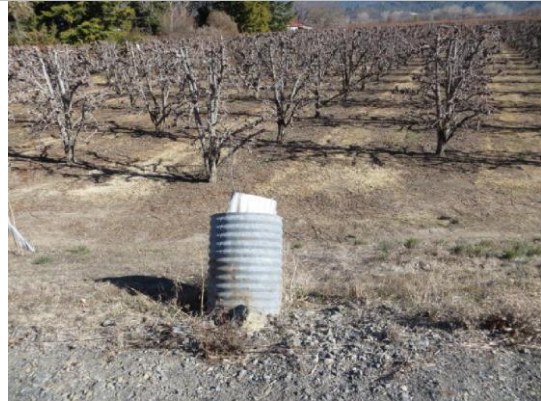
Photo 2 of 3 : UCIP_FA_2015_3386.jpg

Siphon at LS shoulder inside 24-inch CMP riser.

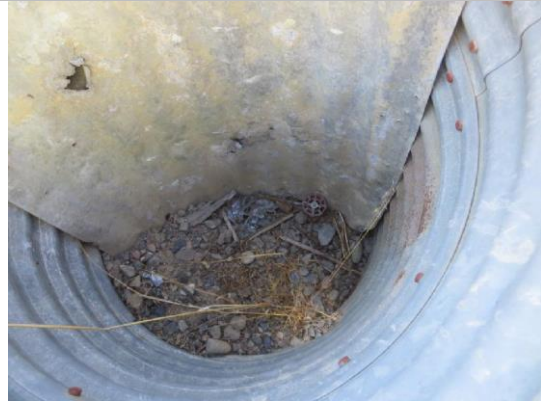
Photo 3 of 3 : UCIP_FA_2015_3387.jpg

Valve visible at bottom of CMP riser on LS shoulder.

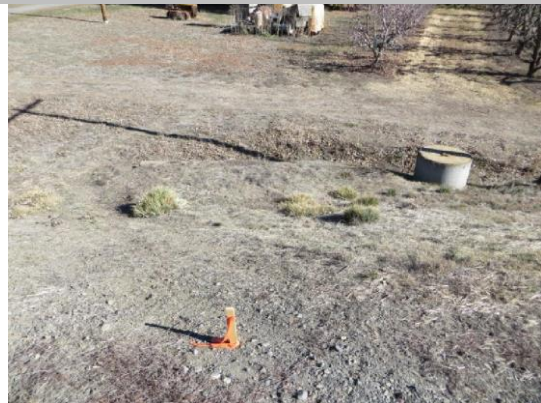
Photo 1 of 3 : UCIP_FA_2015_3108.jpg

LM Start	0.77	Rating **	M	Issue No.	12
LM End	0.77	Issue Type +	En	Location *	LS
Category	Supplemental			GPS Latitude/Longitude	
				Start	End
Item	DWR UCIP Field Study			39.157759 °	39.157759 °
				-122.920301 °	-122.920301 °
DWR ID					
Action/Comments					
Inspector Comments: FS_ID:27892 DS_ID:21220 EP_NO: 11492 FS_HLM: 0.763 Repair Type: Non-Urgent Crossing Status: Found UCIP Comments: Some sediment buildup at inlet. FIELD_STRUCT_DESC: 24-inch CM drainpipe through the levee, 10.0 feet below the crown. Flap gate on the waterward end. Concrete headwalls on both ends. Concrete spillway on waterward slope to bottom of channel. (USACE-1961). This entry matches the Drainage or Irrigation Structure referenced in O&M manual (HLM 0.79). This pipe was retained under ABO No. 11492 (1975). FS Date: 01/22/2014

Concrete headwall visible next to concrete standpipe on LS toe.

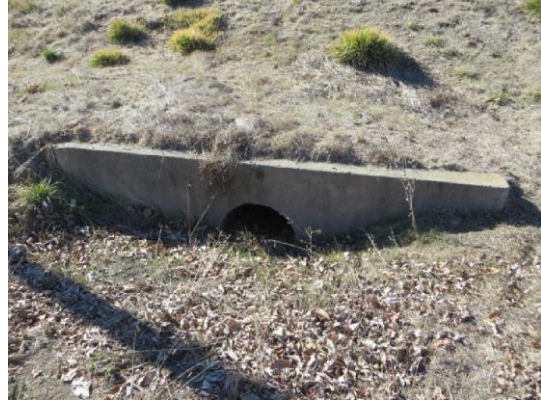
Photo 2 of 3 : UCIP_FA_2015_3388.jpg

Inspector Comments: FS_ID:27892
 DS_ID:21220
 EP_NO: 11492
 FS_HLM: 0.763
 Repair Type: Non-Urgent
 Crossing Status: Found
 UCIP Comments: Some sediment buildup at inlet.
 FIELD_STRUCT_DESC: 24-inch CM drainpipe through the levee, 10.0 feet below the crown. Flap gate on the waterward end. Concrete headwalls on both ends. Concrete spillway on waterward slope to bottom of channel. (USACE-1961). This entry matches the Drainage or Irrigation Structure referenced in O&M manual (HLM 0.79). This pipe was retained under ABO No. 11492 (1975).
 FS Date: 01/22/2014

Concrete headwall visible at LS toe.

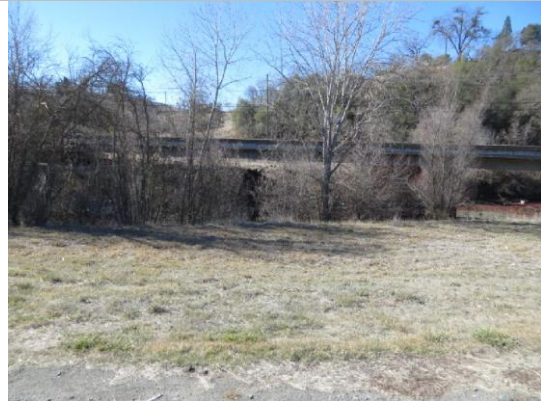
Photo 3 of 3 : UCIP_FA_2015_3389.jpg

Concrete outfall visible off WS berm.

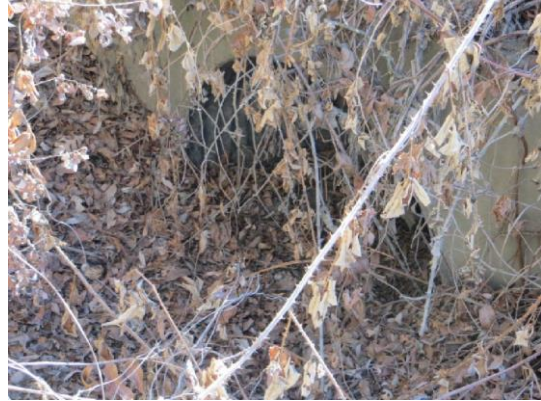
Photo 1 of 3 : UCIP_FA_2015_3109.jpg

Concrete headwall on LS toe.

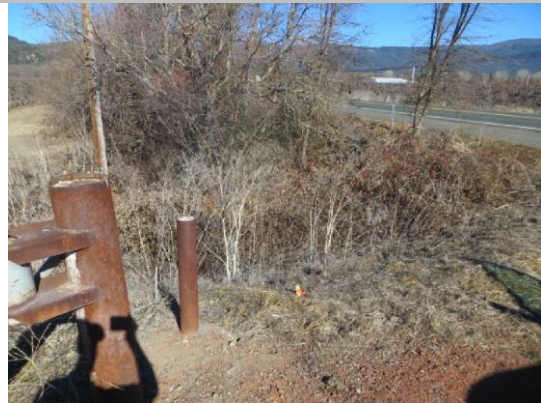
Photo 2 of 3 : UCIP_FA_2015_3110.jpg

Concrete headwall on LS toe.

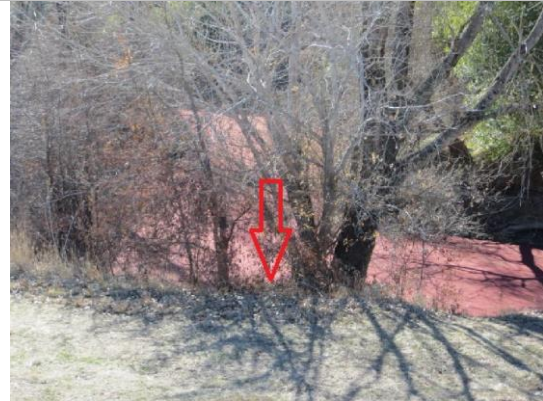
Photo 3 of 3 : UCIP_FA_2015_3111.jpg

Flapgate and headwall off WS toe.

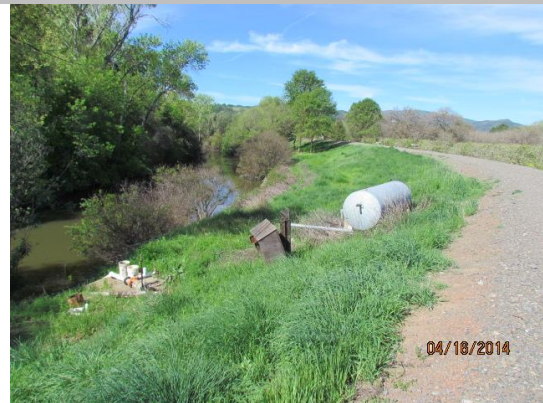
Photo 1 of 1 : FA_2015_NA0009_5_1_20150910_00001.jpg

LM Start	0.99	Rating **	M	Issue No.	1
LM End	0.99	Issue Type +	En	Location *	WS
Category	Earthen Levee			GPS Latitude/Longitude	
				Start	End
Item	Encroachments			39.160108 °	39.160108 °
				-122.922110 °	-122.922110 °
DWR ID	DWR_NA0009_03_s_2012_1				
Action/Comments					
Tank

View of the permitted tank on the waterside slope.

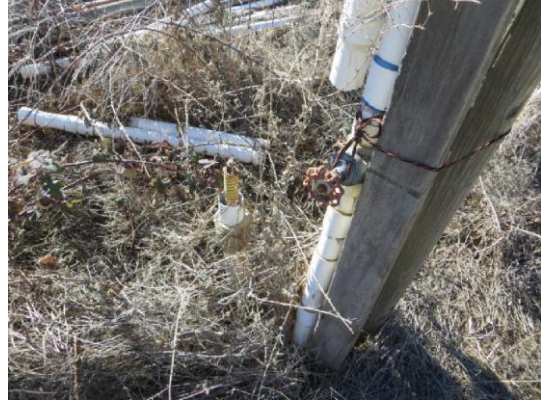
Photo 1 of 3 : UCIP_FA_2015_3112.jpg

LM Start	0.99	Rating **	M	Issue No.	14
LM End	0.99	Issue Type +	En	Location *	WS
Category	Supplemental			GPS Latitude/Longitude	
				Start	End
Item	DWR UCIP Field Study			39.160129 °	39.160129 °
				-122.922117 °	-122.922117 °
DWR ID					
Action/Comments					
Inspector Comments: FS_ID:27903 DS_ID:21248 EP_NO: 11488 FS_HLM: 0.9852 Repair Type: Non-Urgent Crossing Status: Indicator Found UCIP Comments: Siphon breaker standpipe knocked over and covered with dirt. Pipe and appurtances appear to be in disrepair. Gate valves next to tank broken. FIELD_STRUCT_DESC: 6-inch steel irrigation pipe through the levee, 2.5 feet below the crown. Siphon breaker in 24-cmp riser on LS shoulder. Screw gate on waterside slope next to pump and 300-gallon tank. (USACE-1961). This entry matches the Drainage or Irrigation Structure referenced in O&M manual (HLM 1.02). This pipe was retained under ABO No. 11488 (1975). FS Date: 01/22/2014

filler valves on LS toe.

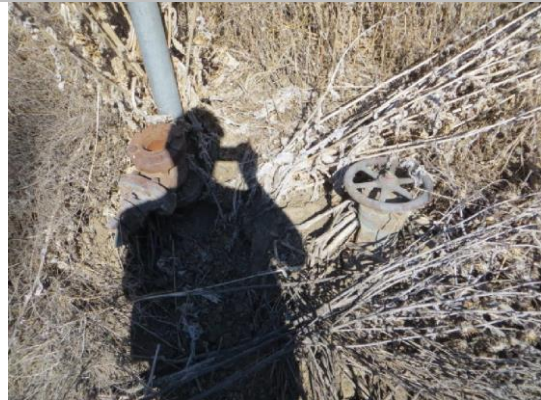
Photo 2 of 3 : UCIP_FA_2015_3113.jpg

Gate valves at tank appear to be in disrepair.

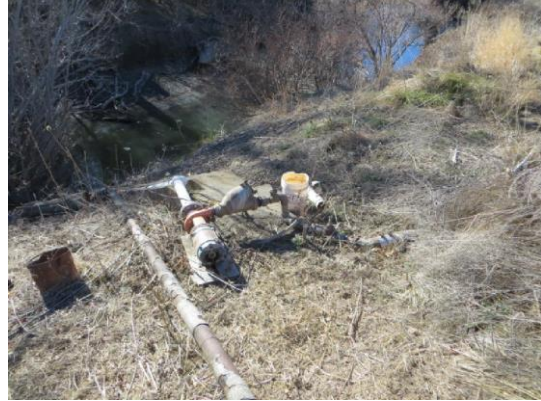
Photo 3 of 3 : UCIP_FA_2015_3114.jpg

Pump at concrete pad on WS berm.

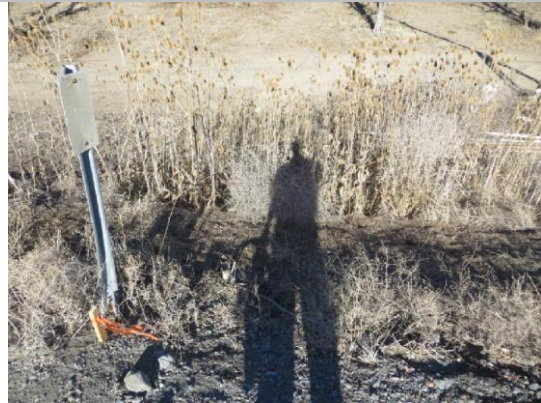
Photo 1 of 3 : UCIP_FA_2015_3115.jpg

LM Start	0.99	Rating **	M	Issue No.	15
LM End	0.99	Issue Type +	En	Location *	WS
Category	Supplemental			GPS Latitude/Longitude	
				Start	End
Item	DWR UCIP Field Study			39.160117 °	39.160117 °
				-122.922144 °	-122.922144 °
DWR ID					
Action/Comments					
Inspector Comments: FS_ID:27943 DS_ID:21222 EP_NO: 11488 FS_HLM: 1.01 Repair Type: Non-Urgent Crossing Status: Found UCIP Comments: Some vegetation buildup at inlet and outlet. FIELD_STRUCT_DESC: 24-inch CM drainpipe through the levee, 14.0 feet below the crown. Flap gate on the waterward end. Concrete headwalls on both ends. (USACE-1961). This entry matches the Drainage or Irrigation Structure referenced in O&M manual (HLM 1.01). This pipe was retained under ABO No. 11488 (1975). FS Date: 01/22/2014

Pipe location marked on crown by flasher.

Inspector Comments: FS_ID:27943
 DS_ID:21222
 EP_NO: 11488
 FS_HLM: 1.01
 Repair Type: Non-Urgent
 Crossing Status: Found
 UCIP Comments: Some vegetation buildup at inlet and outlet.
 FIELD_STRUCT_DESC: 24-inch CM drainpipe through the levee, 14.0 feet below the crown. Flap gate on the waterward end. Concrete headwalls on both ends. (USACE-1961). This entry matches the Drainage or Irrigation Structure referenced in O&M manual (HLM 1.01). This pipe was retained under ABO No. 11488 (1975).
 FS Date: 01/22/2014

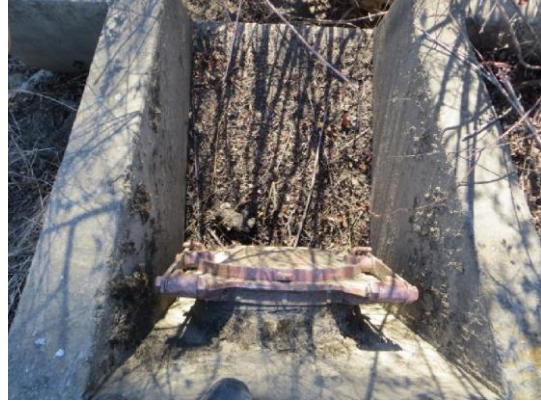
Photo 2 of 3 : UCIP_FA_2015_3116.jpg

Headwall and flapgate on WS berm.

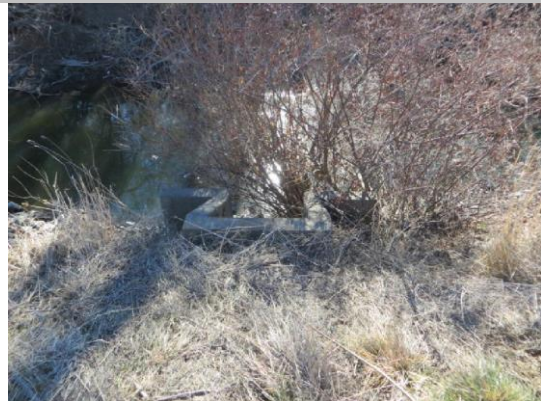
Photo 3 of 3 : UCIP_FA_2015_3117.jpg

Concrete Headwall on WS berm.

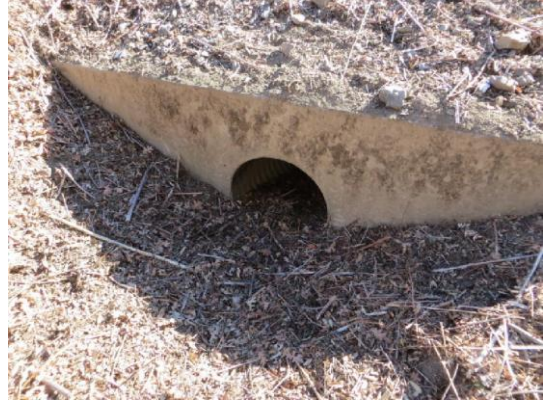
Photo 1 of 3 : UCIP_FA_2015_3118.jpg

LM Start	1.07	Rating **	M	Issue No.	16
LM End	1.07	Issue Type +	En	Location *	WS
Category	Supplemental			GPS Latitude/Longitude	
				Start	End
Item	DWR UCIP Field Study			39.159803 °	39.159803 °
				-122.923501 °	-122.923501 °
DWR ID					
Action/Comments					
Inspector Comments: FS_ID:27944					
DS_ID:21223					
EP_NO: 11489					
FS_HLM: 1.06					
Repair Type: Non-Urgent					
Crossing Status: Found

Concrete headwall on LS toe.

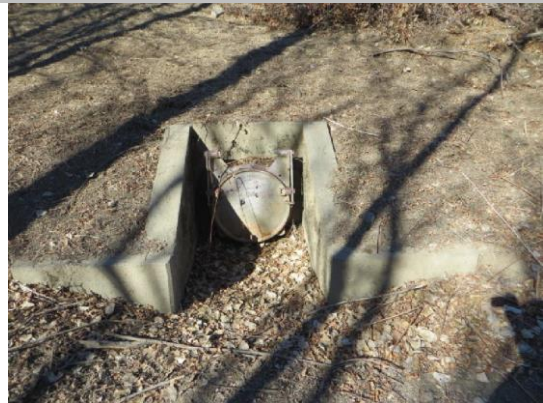
Photo 2 of 3 : UCIP_FA_2015_3119.jpg

Flapgate and headwall visible on WS toe.

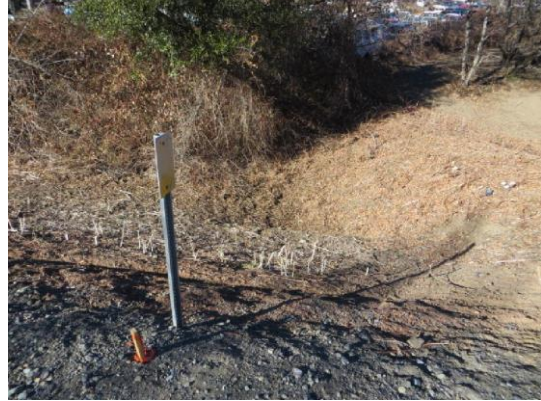
Photo 3 of 3 : UCIP_FA_2015_3120.jpg

Flasher on crown marks pipe location.

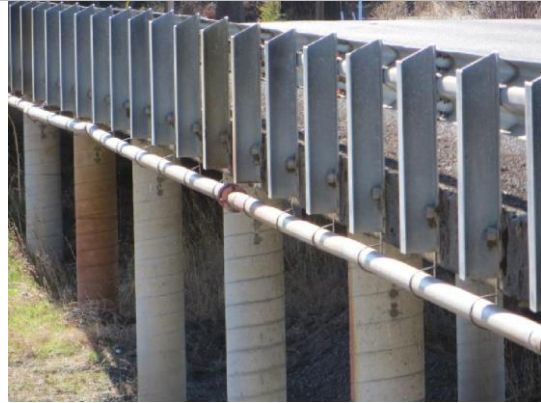
Photo 1 of 3 : UCIP_FA_2015_3421.jpg

Inspector Comments: FS_ID:26907
 DS_ID:21226
 EP_NO: 6303
 FS_HLM: 0.528
 Repair Type: Non-Urgent
 Crossing Status: Found
 UCIP Comments: Pipe open on waterwardside and should be plugged.
 FIELD_STRUCT_DESC: 4-inch steel irrigation pipe through the levee, 1.5-feet below the crown. Steel cutoff wall around the pipe at center of levee. Pipe connects to 4-inch exposed aluminum pipe connected to upstream side of bridge (Permit No. 6303-1969).
 FS Date: 01/09/2014

Pipe visible on upstream side of bridge.

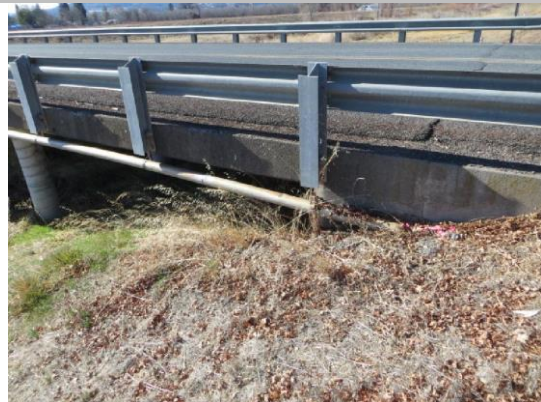
Photo 2 of 3 : UCIP_FA_2015_3422.jpg

Pipe visible on upstream side of bridge.

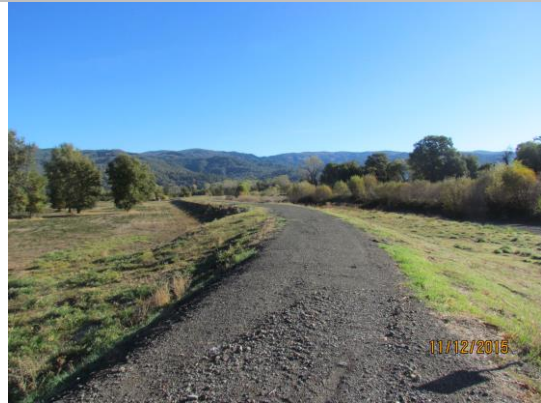
Photo 1 of 1 : FA_2015_NA0009_6_5_20151112_00008.jpg

LM Start	0.54	Rating **	A	Issue No.	5
LM End	0.54	Issue Type +	Ma	Location *	LS
Category	Earthen Levee			GPS Latitude/Longitude	
				Start	End
Item	Vegetation			39.176410 °	39.176410 °
				-122.902590 °	-122.902590 °
DWR ID	DWR_NA0009_04_f_2015_5				
Action/Comments					
Control annual grass and weeds on the levee slopes and easements. Inspector Comments: Lake Co. mowed both slopes.

View of acceptable vegetation on both slopes.

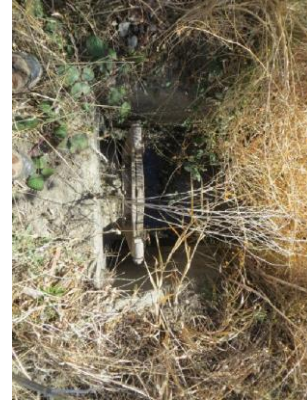
Photo 1 of 3 : UCIP_FA_2015_3424.jpg

Action/Comments					
Inspector Comments: FS_ID:43043 DS_ID:21227 EP_NO: 11501 FS_HLM: 0.755 Repair Type: Urgent Crossing Status: Found UCIP Comments: Pipe rusted through at connection to flapgate. Good indication pipe may need replacement. Video inspection recommended. FIELD_STRUCT_DESC: 24-inch CM drainpipe through the levee, 13.8 feet below the crown. Flap gate on the waterward end. Concrete headwalls on both ends. Originally included in the 1961 O&M manual This pipe was retained under ABO No. 11501 (1975). FS Date: 01/09/2014

Flapgate at concrete headwall on WS toe.

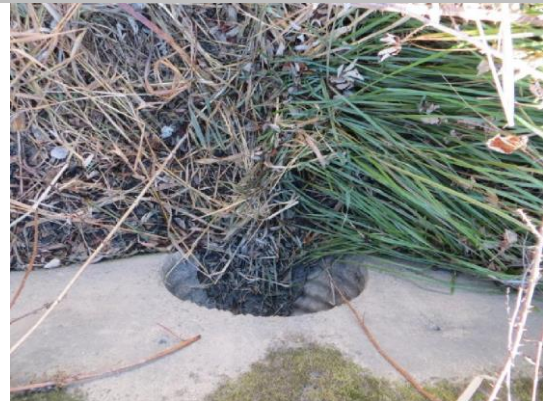
Photo 2 of 3 : UCIP_FA_2015_3425.jpg

Pipe and concrete headwall visible in drainage channel on LS toe.

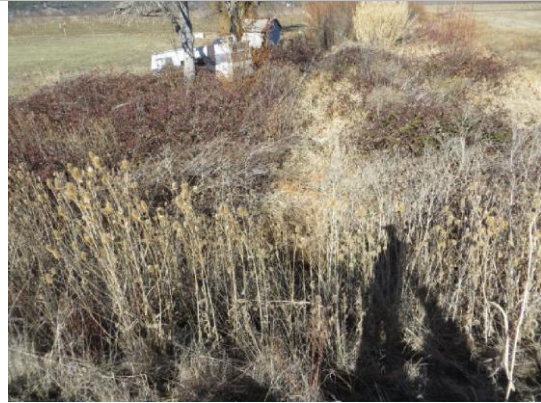
Photo 3 of 3 : UCIP_FA_2015_3426.jpg

Drainage canal at inlet on LS toe.

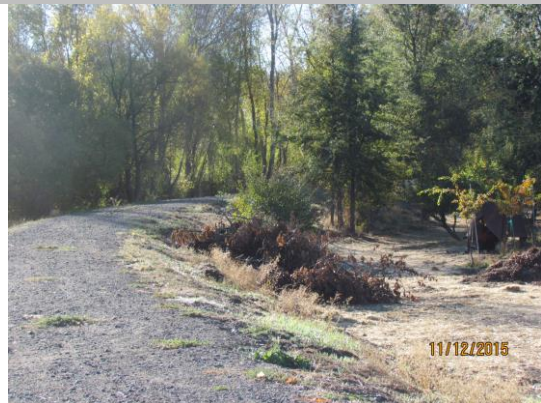
Photo 1 of 1 : FA_2015_NA0009_6_4_20151112_00007.jpg

LM Start	0.93	Rating **	M	Issue No.	4
LM End	0.93	Issue Type +	En	Location *	LS
Category	Earthen Levee			GPS Latitude/Longitude	
				Start	End
Item	Encroachments			39.178990 °	39.178990 °
				-122.896668 °	-122.896668 °
DWR ID	DWR_NA0009_04_f_2015_4				
Action/Comments					
Prunings					
Inspector Comments: Remove the prunings from the landside slope.

View of the prunings along the landside slope.

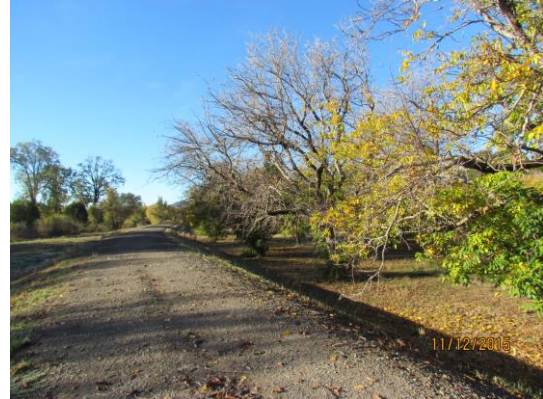
Photo 2 of 2 : FA_2015_NA0009_6_2_20151112_00006.jpg

LM Start	1.05	Rating **	M	Issue No.	2 (cont)
LM End	1.18	Issue Type +	Ma	Location *	LS
Category	Earthen Levee			GPS Latitude/Longitude	
				Start	End
Item	Trim / Thin Trees			39.180479 °	39.181947 °
				-122.896567 °	-122.895112 °
DWR ID	DWR_NA0009_04_s_2012_2				
Action/Comments					
Trim trees to at least five feet above ground level.					
Inspector Comments: Trim the trees up 5 feet for better visibility.

Trim the trees up 5 feet for better visibility.

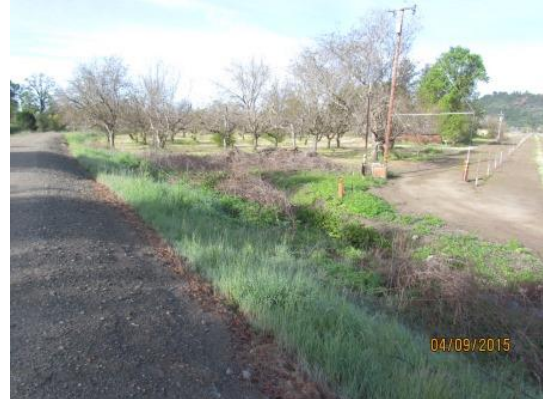
Photo 1 of 2 : FA_2015_NA0009_6_9_20150910_00002.jpg

LM Start	1.19	Rating **	M	Issue No.	9
LM End	1.26	Issue Type +	Ma	Location *	LS
Category	Earthen Levee			GPS Latitude/Longitude	
				Start	End
Item	Vegetation			39.182154 °	39.182951 °
				-122.895005 °	-122.894409 °
DWR ID	DWR_NA0009_04_s_2012_9				
Action/Comments					
Remove the wild growth other than native grasses from the levee slopes.					
Inspector Comments: Remove the vegetation from the landside toe.

View of the vegetation growing at the toe.

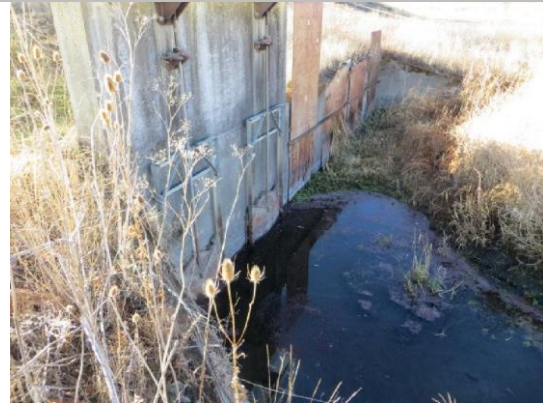
Photo 1 of 3 : UCIP_FA_2015_3418.jpg

LM Start	0.31	Rating **	M	Issue No.	11
LM End	0.31	Issue Type +	En	Location *	LS
Category	Supplemental			GPS Latitude/Longitude	
				Start	End
Item	DWR UCIP Field Study			39.177076 °	39.177076 °
				-122.898879 °	-122.898879 °
DWR ID					
Action/Comments					
Inspector Comments: FS_ID:26897					
DS_ID:21235					
EP_NO: 11507					
FS_HLM: 0.314					
Repair Type: Non-Urgent					
Crossing Status: Found					
UCIP Comments: Some sediment buildup at LS toe.					
FIELD_STRUCT_DESC: 1 of 6: 36-inch CM irrigation pipe through the					
levee, 12.0 feet below the crown. Slide gate on waterward end. Steel					
walkway on waterward slope to slide gate. Concrete headwall on both					
ends. Originally included in 1961 O+M manual. Structure and pipes					
retained under ABO Permit No. 11507 (1975).					
FS Date: 01/09/2014

Slide gate at concrete headwall on WS toe.

Inspector Comments: FS_ID:26897
DS_ID:21235
EP_NO: 11507
FS_HLM: 0.314
Repair Type: Non-Urgent
Crossing Status: Found
UCIP Comments: Some sediment buildup at LS toe.
FIELD_STRUCT_DESC: 1 of 6: 36-inch CM irrigation pipe through the levee, 12.0 feet below the crown. Slide gate on waterward end. Steel walkway on waterward slope to slide gate. Concrete headwall on both ends. Originally included in 1961 O+M manual. Structure and pipes retained under ABO Permit No. 11507 (1975).
FS Date: 01/09/2014

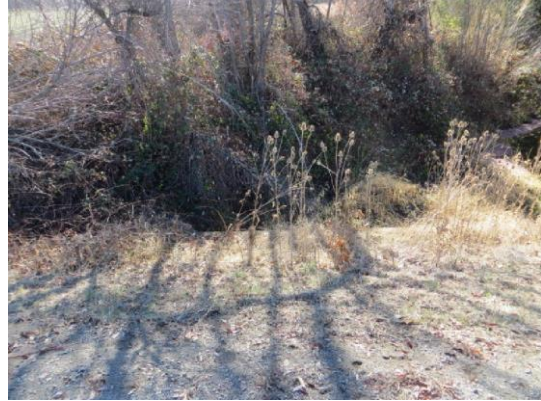
Photo 2 of 3 : UCIP_FA_2015_3419.jpg

Outlet visible at concrete headwall on LS toe.

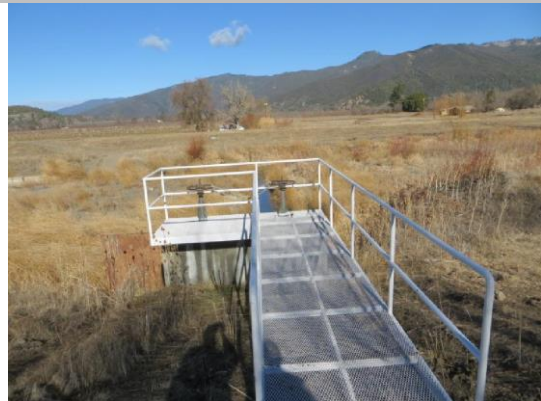
Photo 3 of 3 : UCIP_FA_2015_3420.jpg

Slide gate at steel walkway on WS toe.

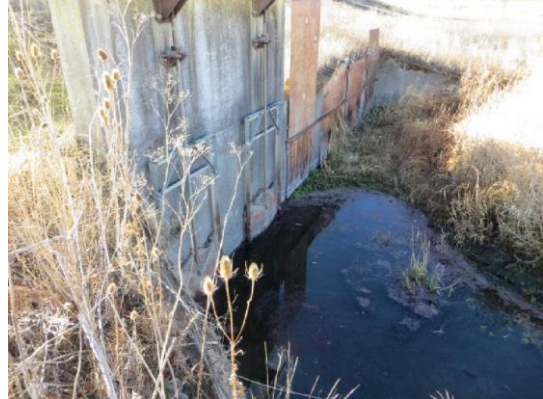
Photo 1 of 3 : UCIP_FA_2015_3415.jpg

LM Start	0.31	Rating **	M	Issue No.	12
LM End	0.31	Issue Type +	En	Location *	LS
Category	Supplemental			GPS Latitude/Longitude	
				Start	End
Item	DWR UCIP Field Study			39.177074 °	39.177074 °
				-122.898902 °	-122.898902 °
DWR ID					
Action/Comments					
Inspector Comments: FS_ID:26891					
DS_ID:21234					
EP_NO: 11507					
FS_HLM: 0.315					
Repair Type: Non-Urgent					
Crossing Status: Found

Slide gate visible at concrete headwall on WS toe.

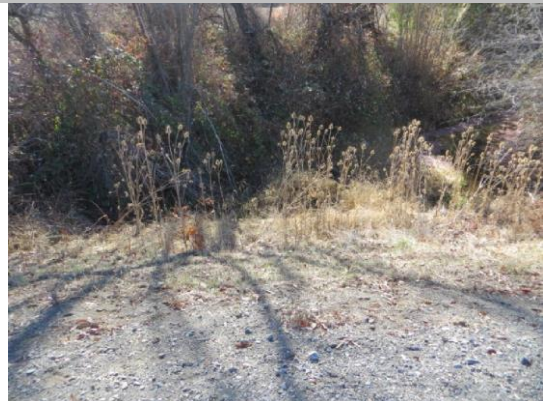
Photo 2 of 3 : UCIP_FA_2015_3416.jpg

Outlet visible at concrete headwall on LS toe.
